7065C19 - LONGITUDINAL MOUNTING (ONE), LEFT OR RIGHT, FOR ROOF RACK BARS - R.R.

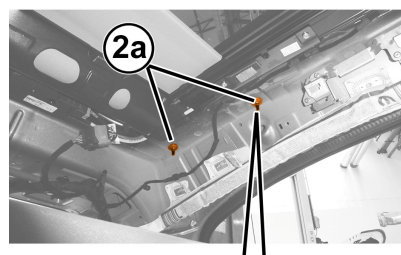
1. Position longitudinal support (1a).

1. Restore the thread lock on the studs (1a).

2. Undo the nuts (2a) and tighten them holding the respective studs (1a) still using their wrench.
